Model	Model Code	Year Model	Issue Date
CIVIC 5D	FK1, FK2, FK3	12	18-05-12
			Originator

Wind Noise From Door Mirror Area

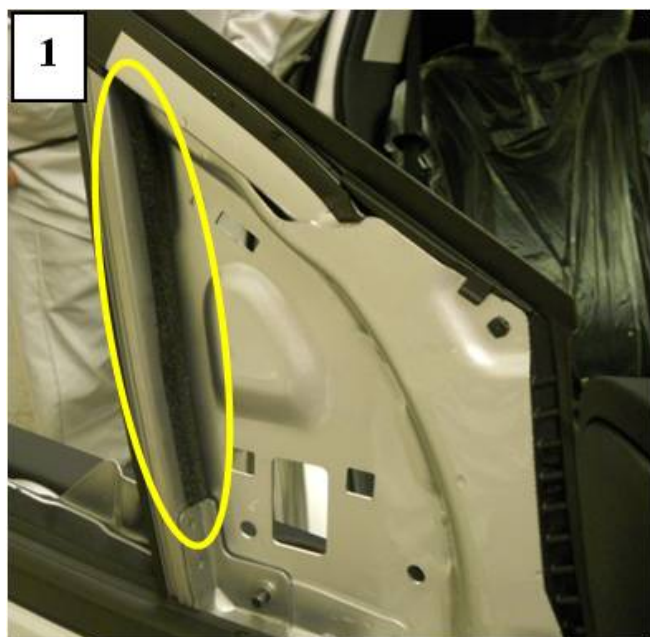
1. The Run channel sash foam has gaps, or is missing.

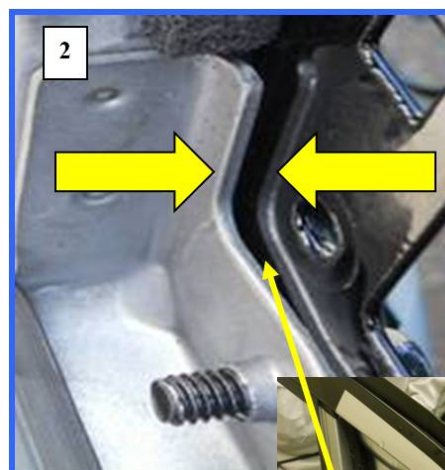
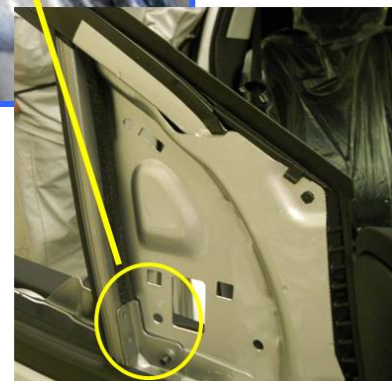
2. Run channel sash bracket gap has excessive clearance at the mirror fixing point.

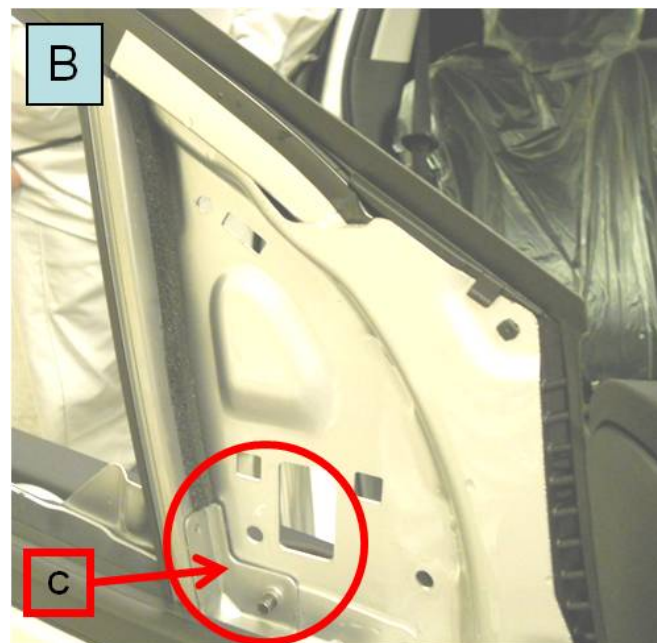
Run channel sash bracket gap (B)

Area of concern is at the Mirror base (C) shown below.

1. Remove the door mirror as described in MaRIS.
2. Degrease the Run Channel sash and bracket.
3. Apply a new piece of foam cut to the dimensions shown below to area B.
4. Make sure to cut a hole so that the door mirror stud passes through the patch.

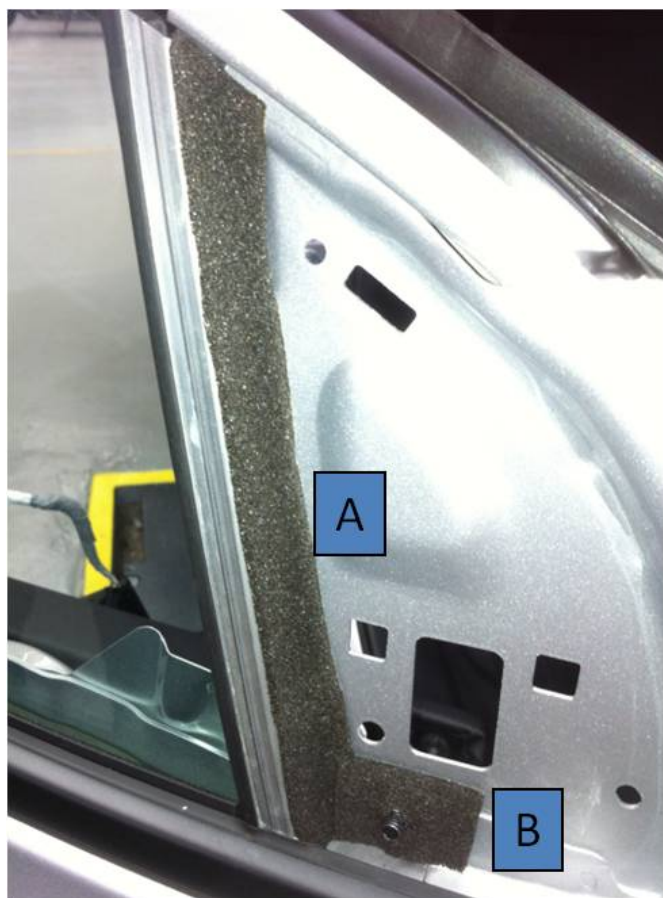
Below shows the completed repair to the Run channel sash and sash bracket with the foam applied to both points A and B.

Re-fit door mirror as described in MARIS. Test Drive the vehicle to ensure that the noise has been eliminated.
