Model	Model Code	Year Model	Issue Date
CIVIC 5D	FK1, FK2, FK3	12	18-05-12
			Originator

Wind Noise From Door Mirror Area

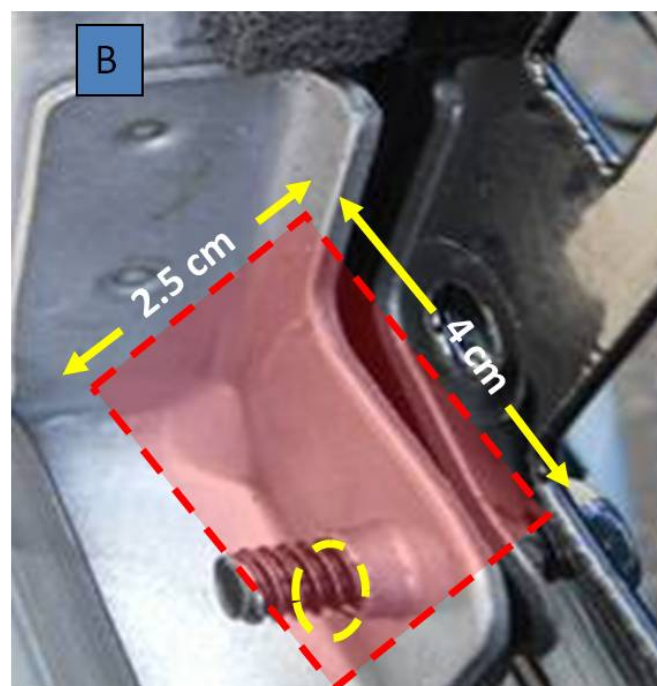
Run channel sash bracket gap (B)

Area of concern is at the Mirror base (C) shown below.

1. Remove the door mirror as described in MaRIS.
2. Degrease the Run Channel sash and bracket.
3. Apply a new piece of foam cut to the dimensions shown below to area B.
4. Make sure to cut a hole so that the door mirror stud passes through the patch.
